Request for Qualifications

**Holland Creek (Mackie Rd) Dam D720190  
Decommissioning Contractor**

# Holland Creek – Mackie Road Dam (D720190) Preliminary Decommissioning Report

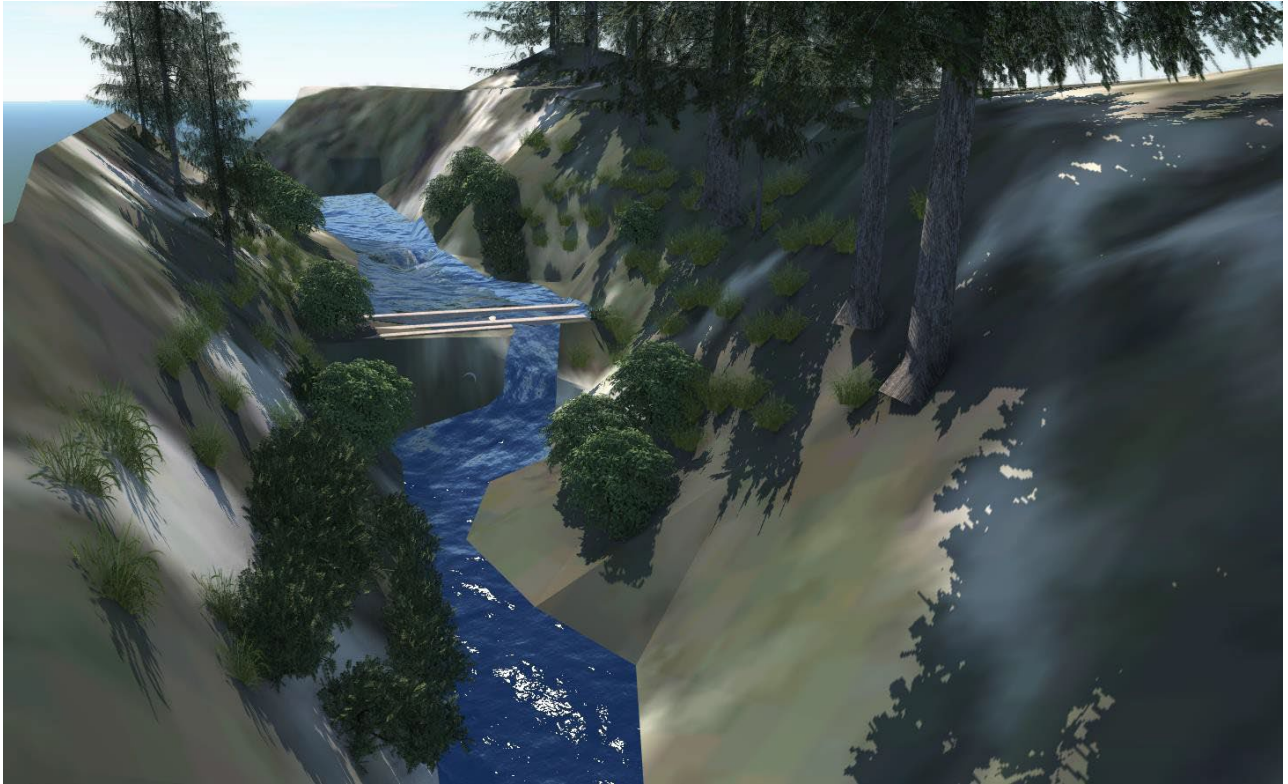
**Figure 4.3 Mackie Rd Dam Existing 3D model**

Based off of the most probable bedrock scenarios, three conceptual designs were produced to illustrate the decommissioning. These can be seen in a preliminary drawing package, Appendix D. The most likely design is scenario 2, this is illustrated in a snapshot from a conceptual 3D model produced in AutoCAD Infravorks, Figure 4.3 & 4.4.

Mackie Road Dam (UTM 10, 439271.650E, 5426221.390N) is a timber crib structure that appears to be founded on bedrock. It consists of interlocking timber cribs, which are typically backfilled with stone. The main timber crib on the upstream end has an approximate diameter/width of 500 mm while the other cribs have an approximate diameter/width of 400 mm. It is assumed that the timber cribs over time have worn from a rough sawn rectangular shape to a squircle (an intermediate shape between a square and circle). The dam has a maximum height of 3.8 m and a width of 12 m. A control structure exists on the left side of the dam consisting of an opening roughly 700 mm wide and 1000 mm high, the concrete structure to the left of the opening is 3.2 m long and 400 mm wide. This concrete wing wall raises the dam crest along this section by approximately 1 m. A timber facing has been placed along the downstream side of the cribbing, presumably to act as a water barrier, and to allow for the construction of a concrete wall behind (upstream) of the timber facing. Over time, the dam's reservoir has infilled with sediment so that it is almost at same level as the dam crest.

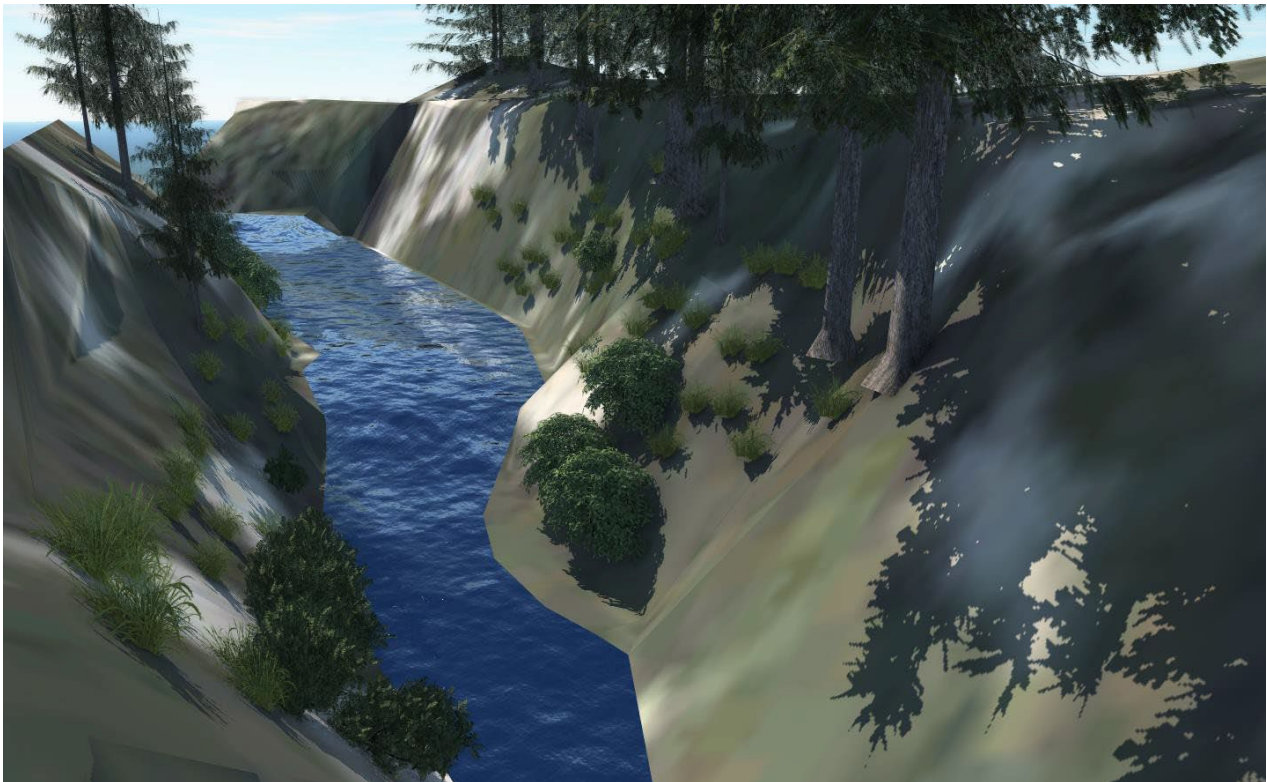
**Figure 4.4 Mackie Rd Dam Removal Scenario 2 Shallow Grade 3D model**

2. **Scenario 2 (Shallow Grade):** In order to achieve approximately the same grade as the current natural channel, the grading will need to extend ~35 m upstream of the dam. This scenario will govern if bedrock is not uncovered or is not at a reasonable depth below the existing grade. This will not require thorough sediment management post decommissioning due to the shallow grade.

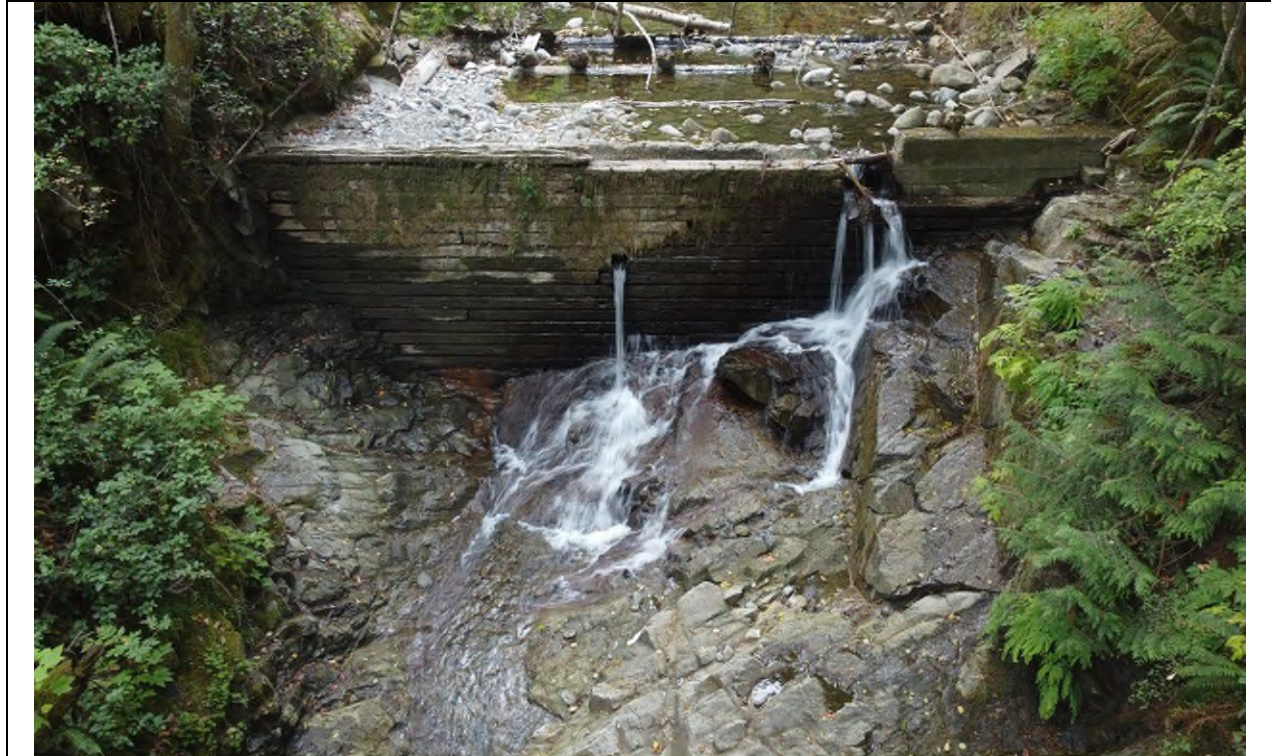
| Photo No. 1 | Date: 19 September 2023 | Looking Towards: West | Location: Mackie Road Dam |

| Description: Looking at Mackie Road Dam during the low flow period. | | | |

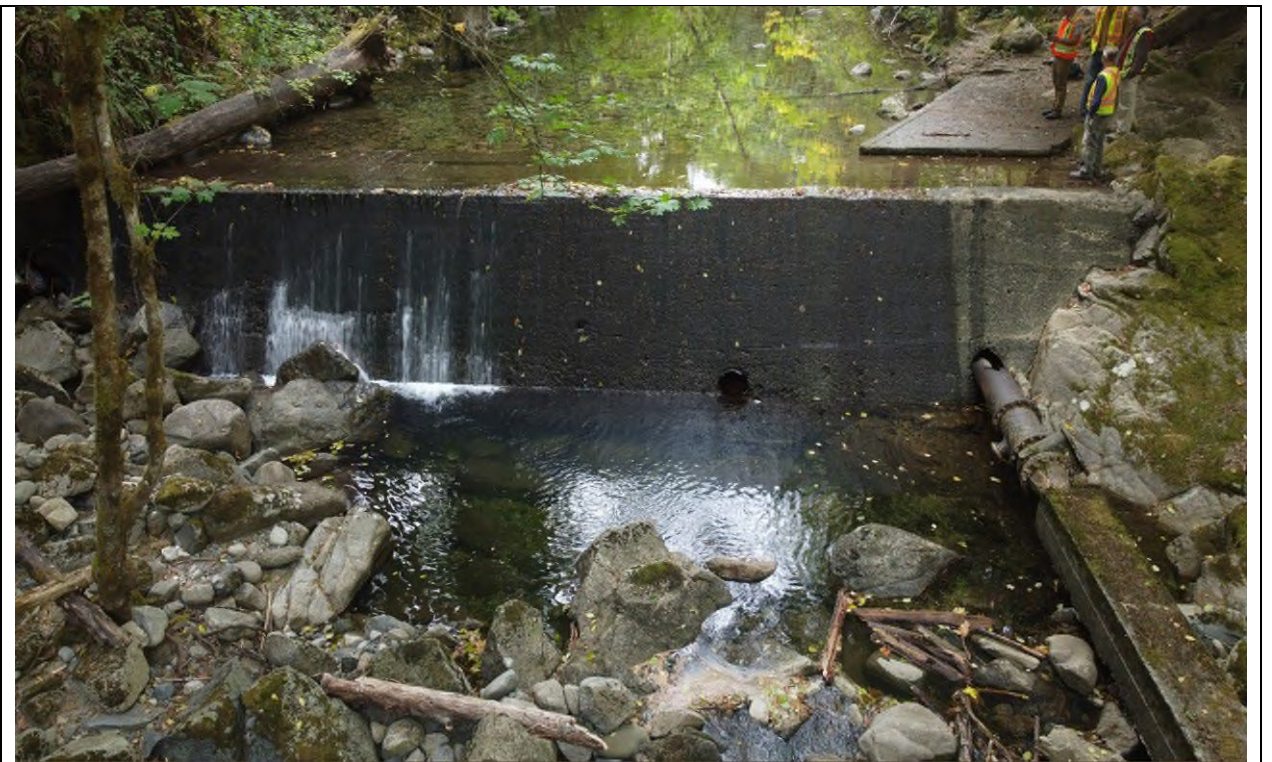
| Photo No. 6 | Date: 19 September 2023 | Looking Towards: South | Location: Colonia Drive Dam |

| Description: Looking at Colonia Drive Dam during the low flow period. | | | |

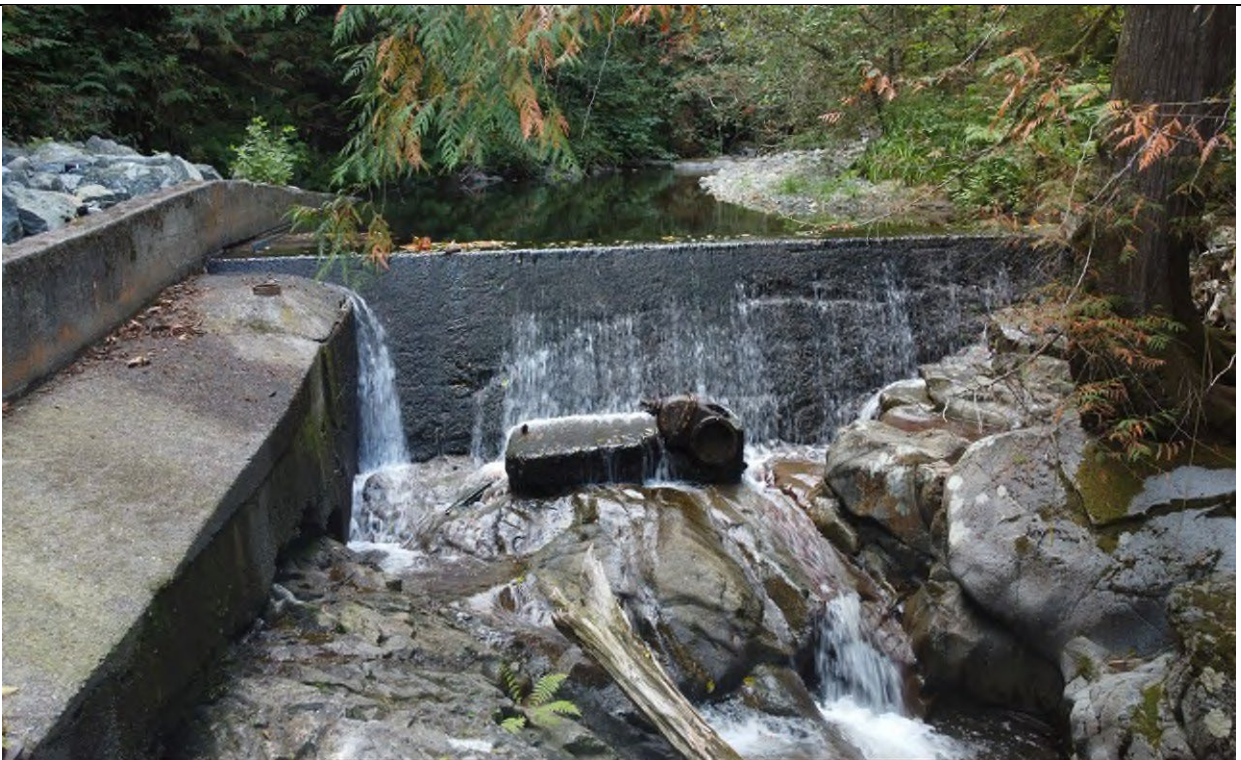
| Photo No. 12 | Date: 19 September 2023 | Looking Towards: West | Location: Water Supply Dam |

| Description: Looking at Water Supply Dam during the low flow period. | | | |

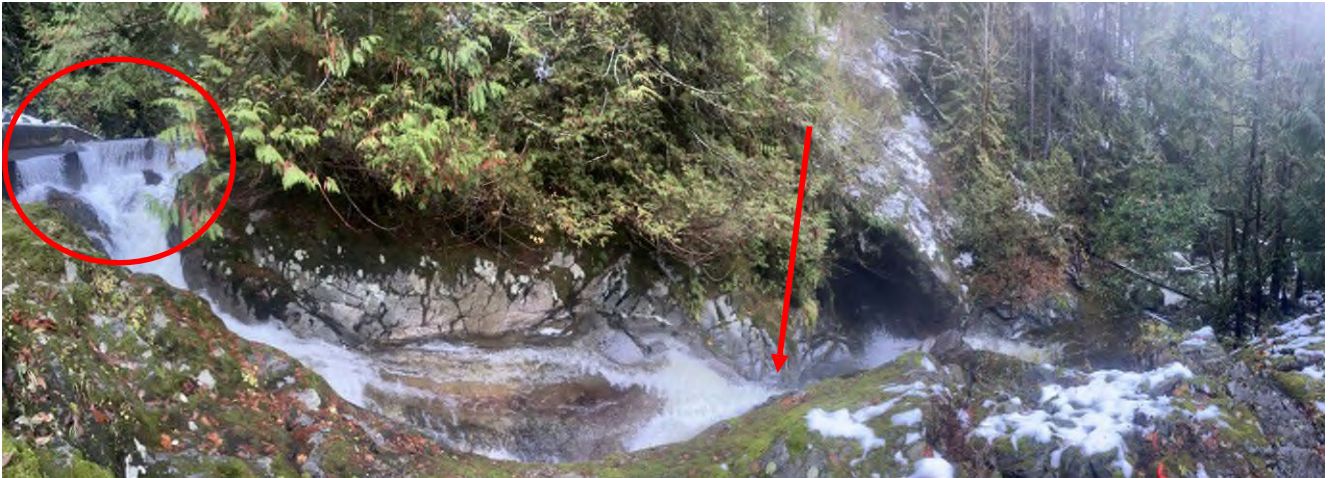
| Photo No. 17 | Date: 27 October 2023 | Looking Towards: East | Location: Water Supply Dam |

| Description: Looking at the instream feature (i.e., fall, red arrow) located to the immediate downstream of Water Supply Dam (red circle) during the wet season. | | | |

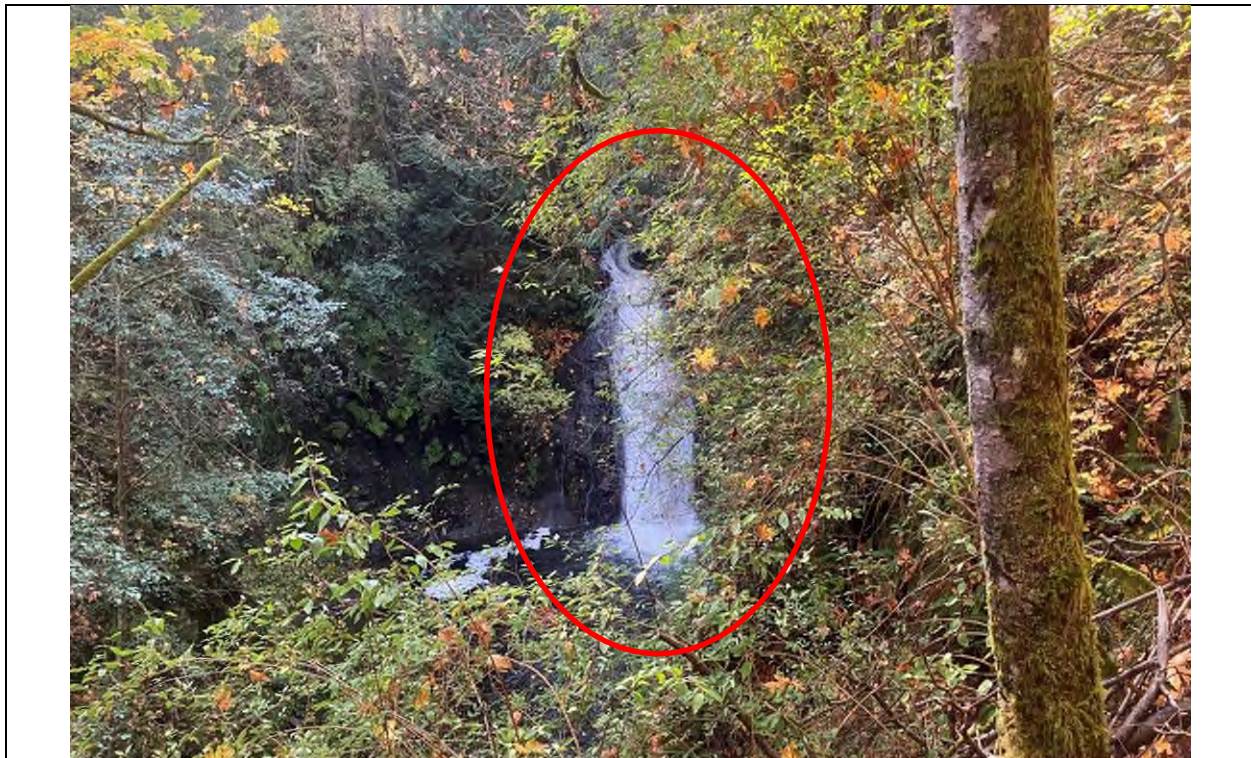
| Photo No. 20 | Date: 28 October 2023 | Looking Towards: West | Location: 50 m Downstream of Mackie Road Dam |

| Description: Looking at the permanent fist barrier (i.e., waterfall, red oval) approximately 50 m downstream of Mackie Road Dam. | | | |

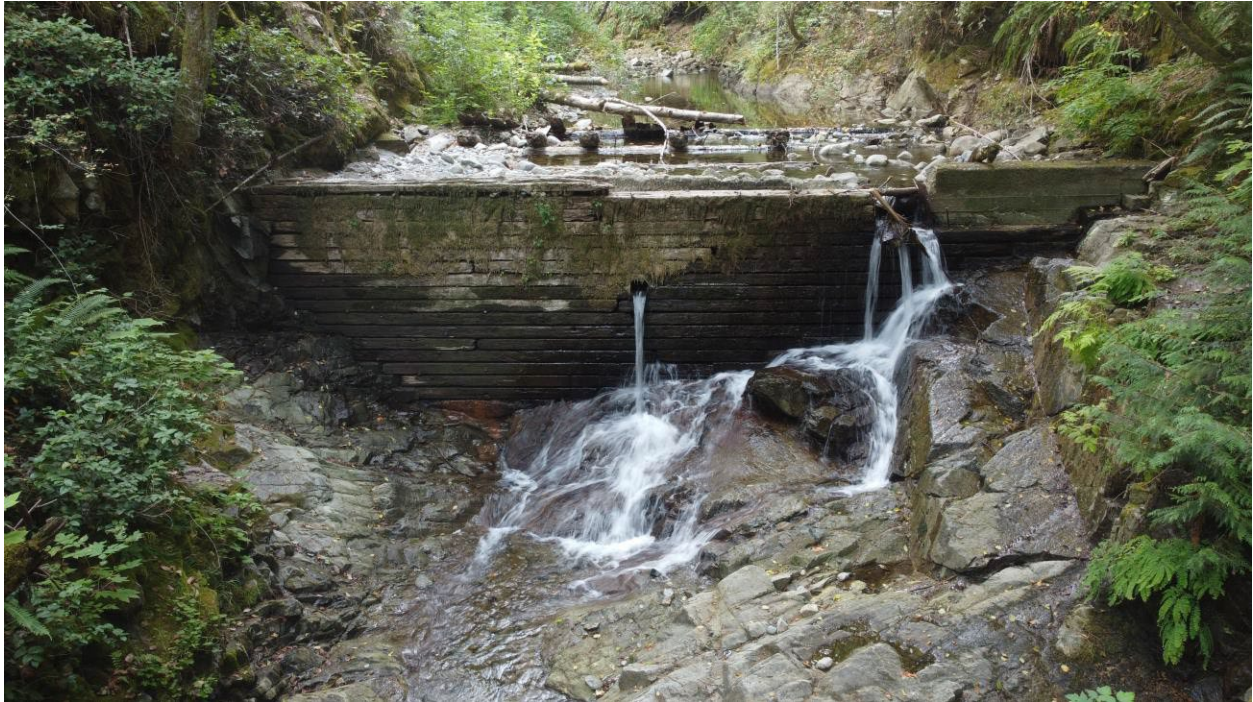
Photo 1 Downstream face of dam, looking southwest.

Photographs of the dam were taken during the DSI with a standard camera as well as a DJI Mini 2 micro drone. Photographs of the dam site are included in Appendix C. Photographs are numbered 1 to 8 and document the condition of the dam during Ecora's site inspection on September 17, 2023.

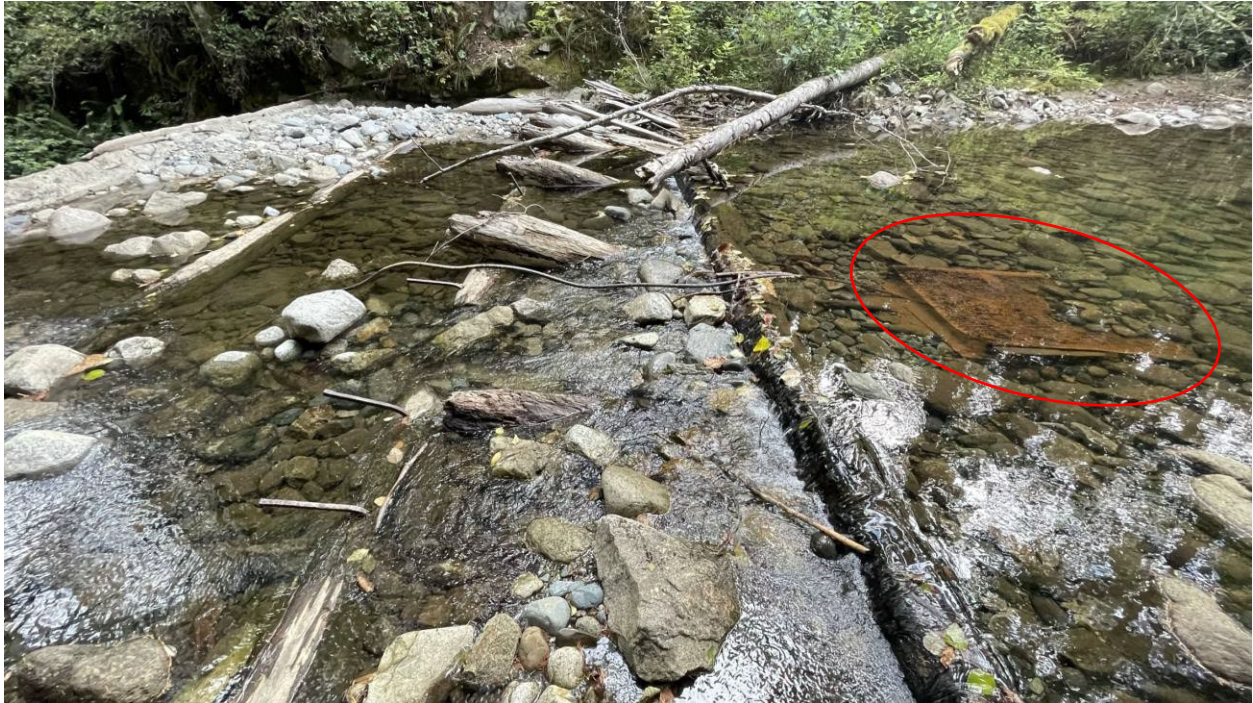
Photo 2 Low-Level metal intake grate and remnants of wooden flashboards, looking east (from left side of dam).

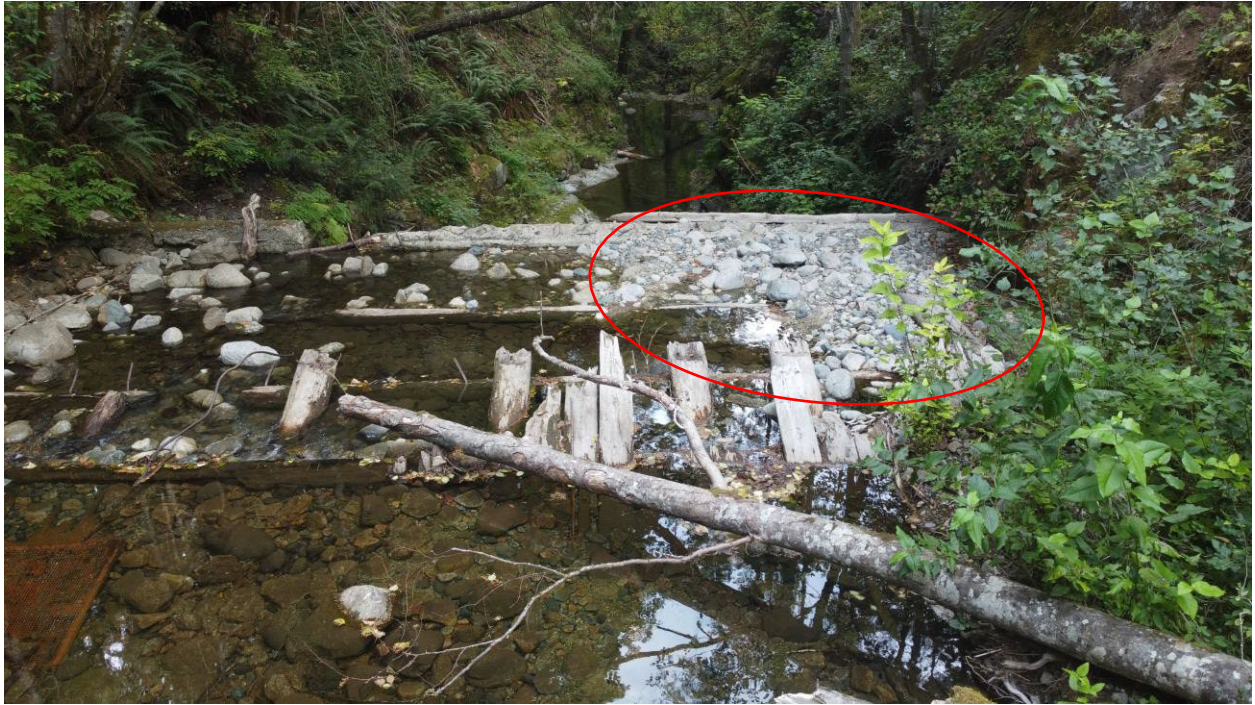
Photo 3 Top of dam with debris buildup on right side, looking northeast (downstream).

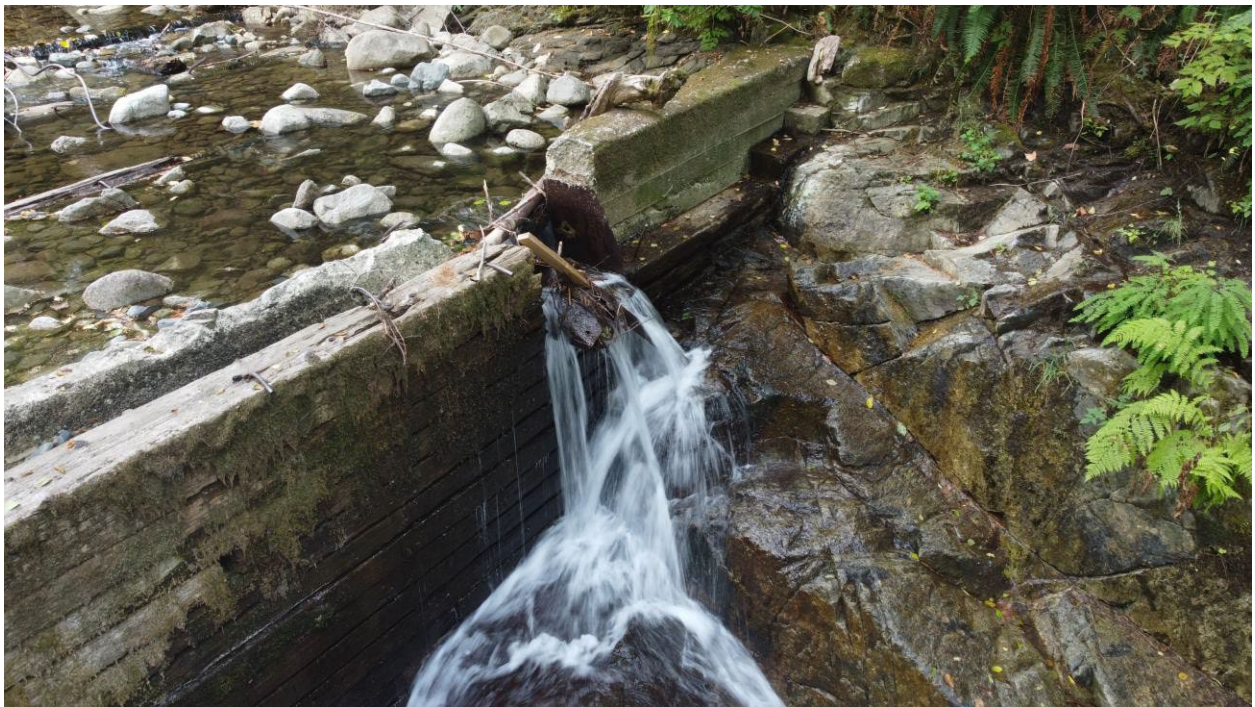
Photo 4 Control Structure on left side, view 1.

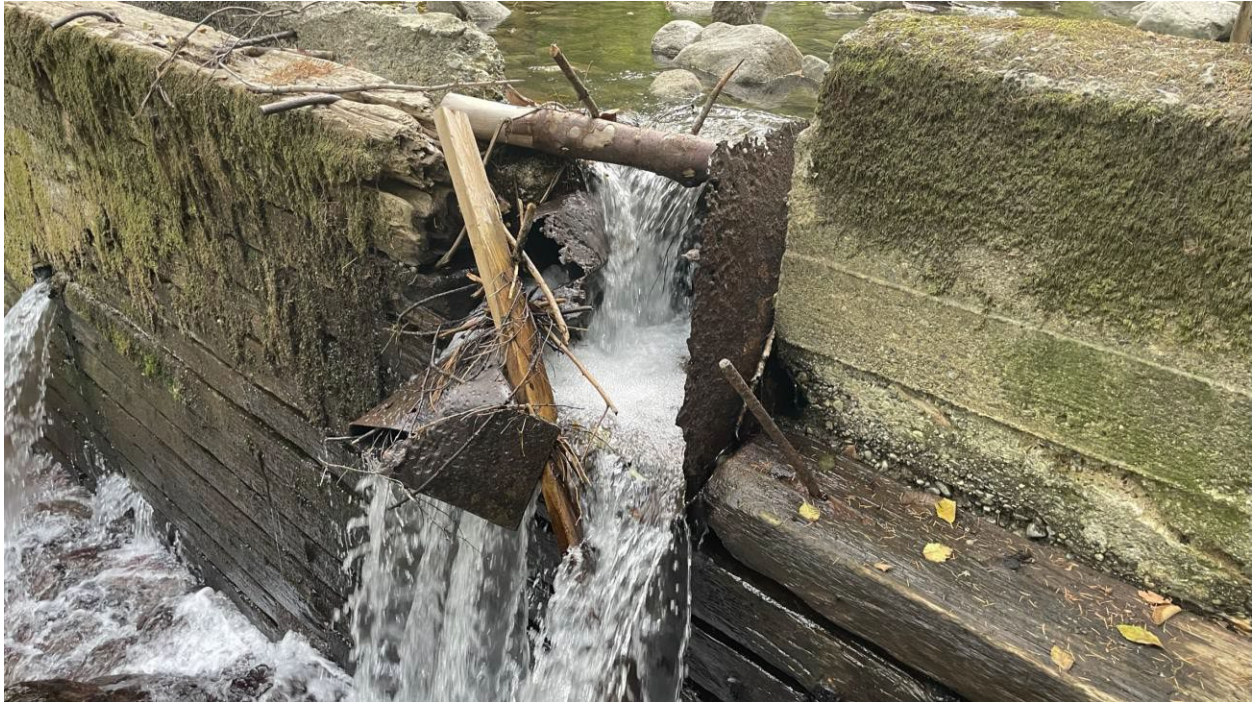
**Photo 5** Control Structure on left side, view 2.

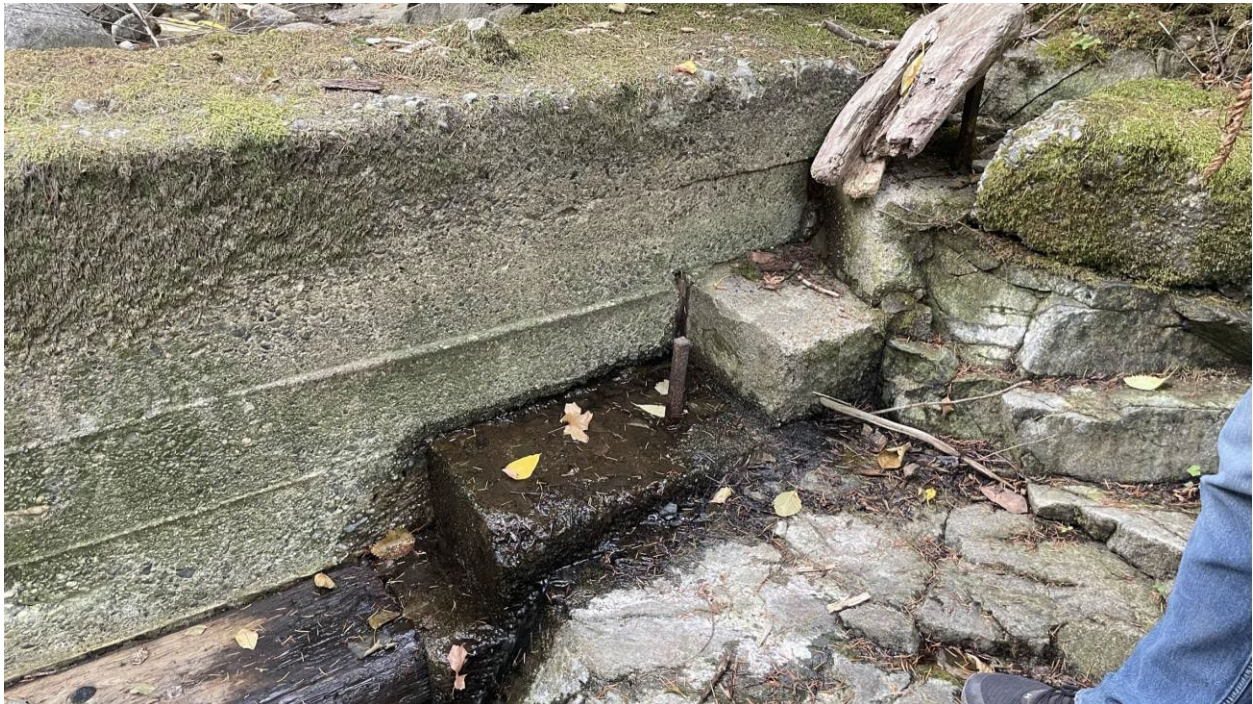
**Photo 6** Seepage underneath left concrete abutment.

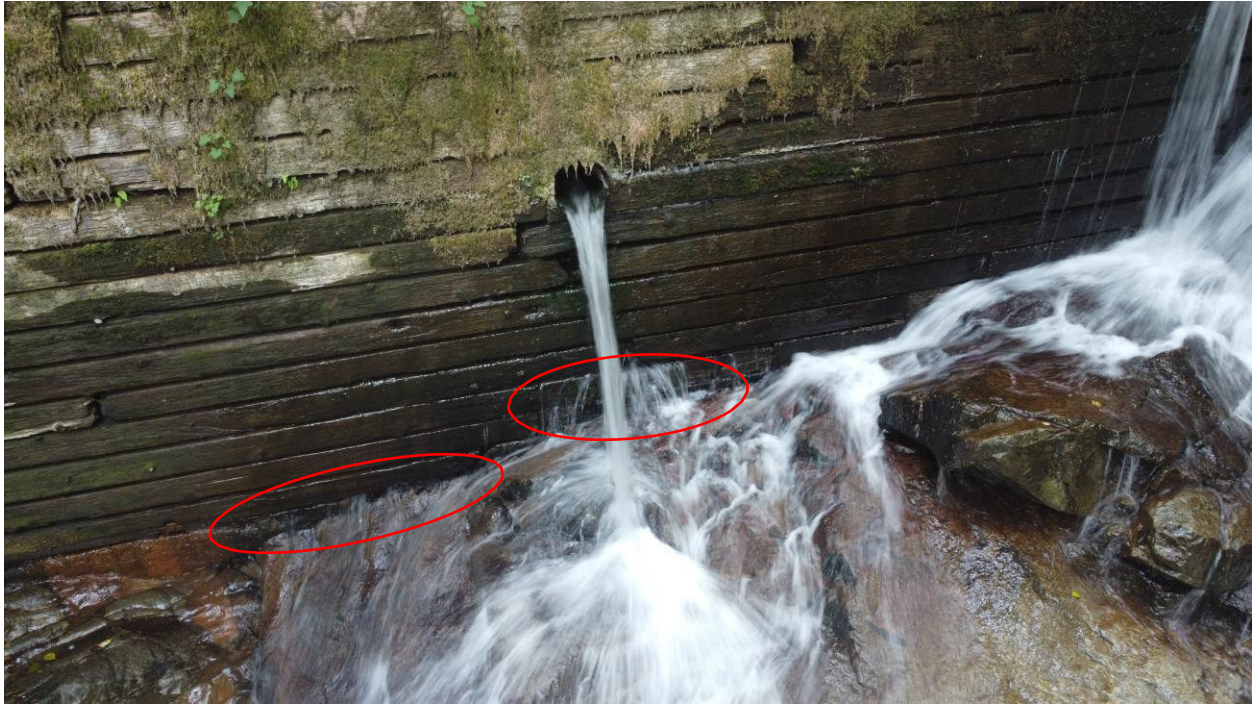
**Photo 7** Major seepage at toe of downstream face.

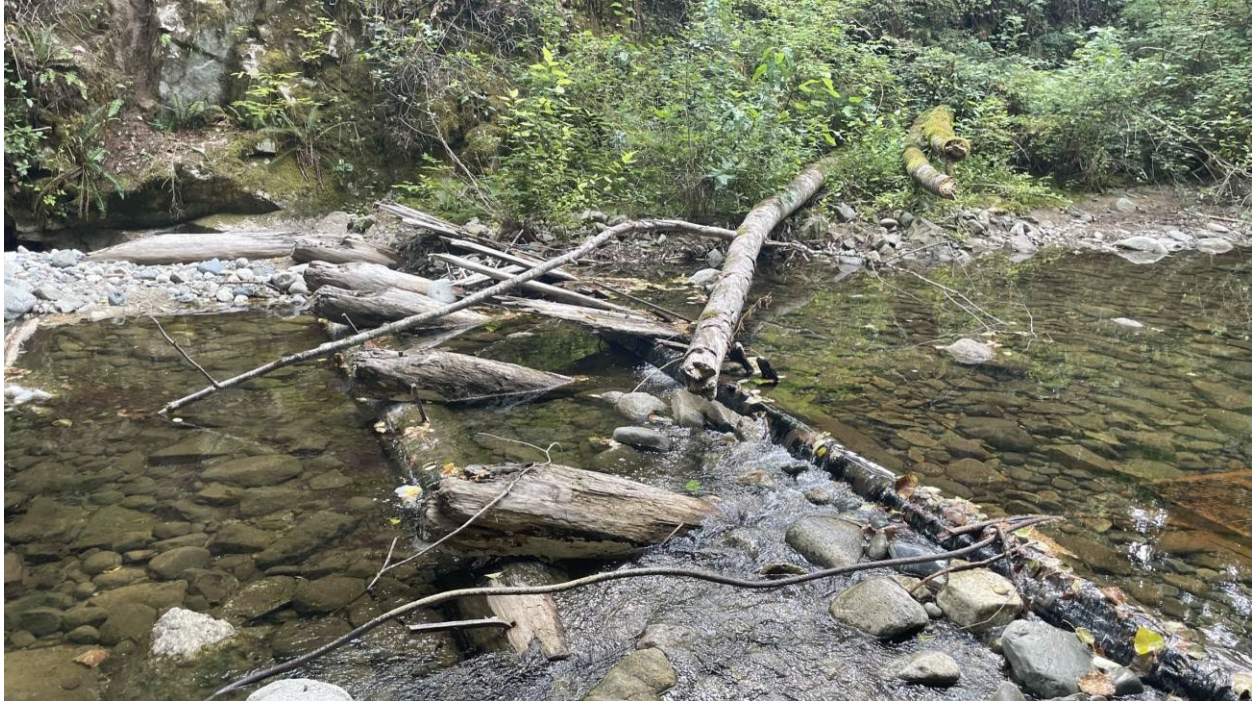
**Photo 8** Vegetation built up on remnants of wooden flashboards on right side of upstream channel & miscellaneous debris.
